**BUILDING SURVEY ON:**

**111 ARCACIA AVENUE  
LONDON  
N14 ABC**

Our ref: PBS1035

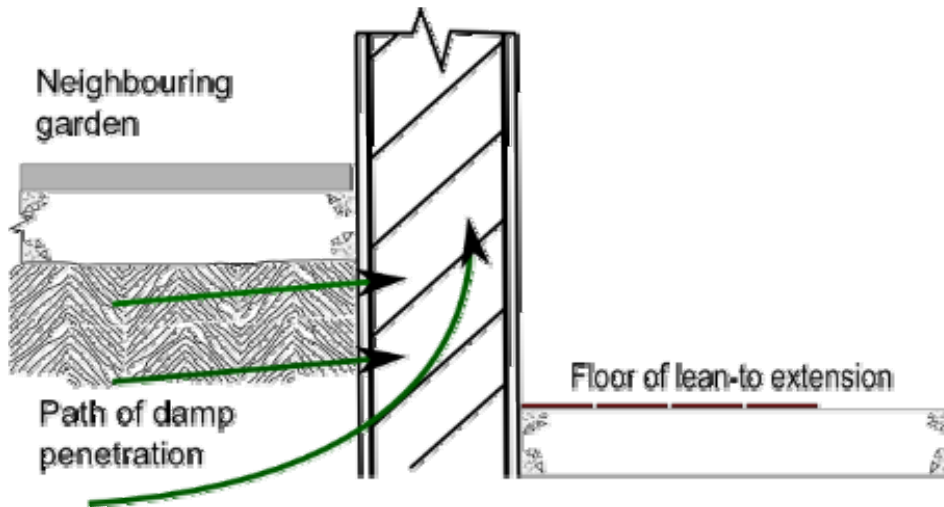
High levels of damp were noted to the outer walls of the lean-to side extension. This has caused significant damage to plastered surfaces.

The problem is caused by high external paving levels, adjacent to the affected walls, in the neighbouring property's garden. The picture below illustrates the difference in ground levels.

The moisture which is present in the ground below the paving penetrates through the wall as it is above any damp proof course that may be present in the boundary wall (see sketch below)

Methods of damp-proofing a wall which backs on to sub-soil are similar to those used in basements. There are two methods in common use; the first involves lining the wall with a waterproof membrane; a cavity is left between the original wall and the membrane into which the excess water drips to be collected in specially constructed drainage channels and sumps below the floor. The water is then slowly pumped away. The second method involves building up layers of waterproof render in a method known as “tanking”. Both methods are expensive.
