Building Survey Report

1 Example Road
Example County
Example Postcode

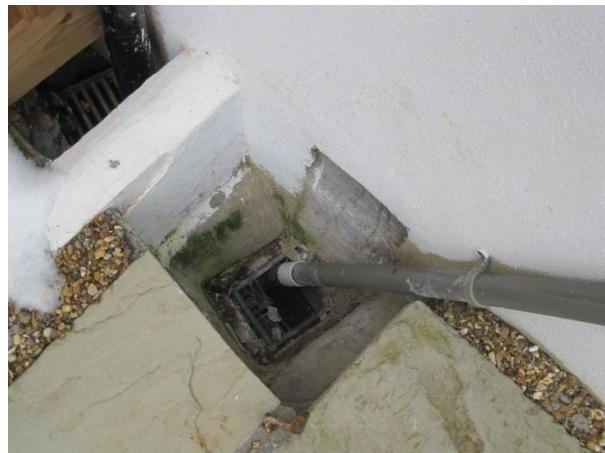
Partial cover to gully

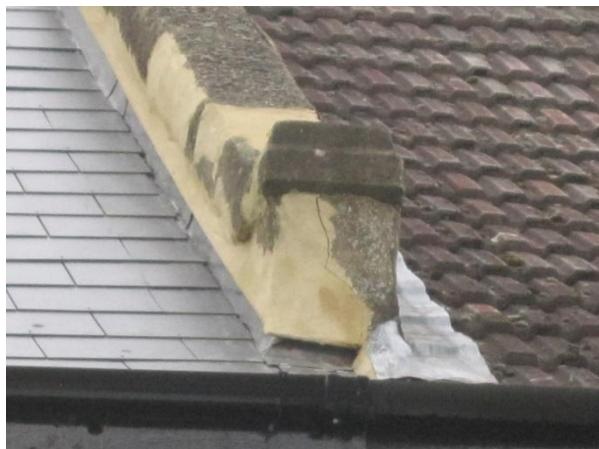
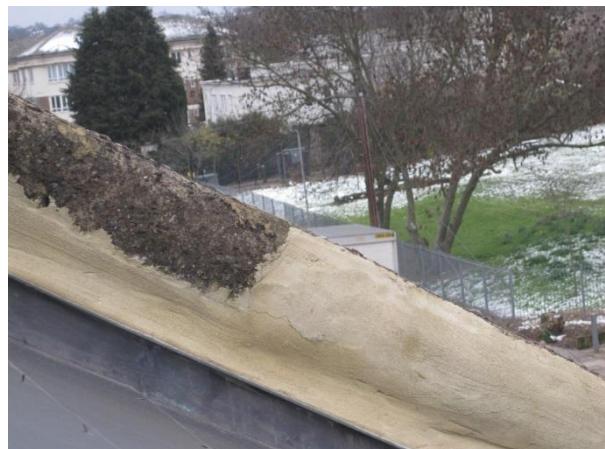
There is a rendered party parapet wall to the front of the property. The render was patch repaired as part of the recent works. There is a visible crack to the front elevation and several hairline cracks where the new render has dried out and shrunk. It is a matter of time before rainwater gets in to the cracks, freezes and causes the render to de-bond and eventually fall away. You should budget to hack off all of the render and renew it.

Defective render to party parapet wall

Defective render to party parapet wall (2)

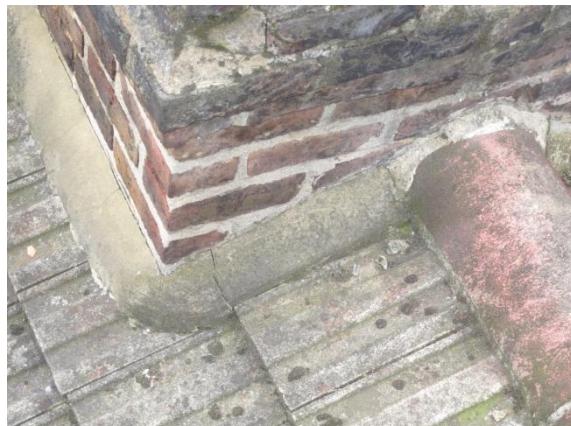
The junction between the tiles and the chimney stack is sealed with a stiff mortar joint (known as a cement fillet). This type of joint does not allow for any thermal movement and is therefore considered inferior to a sheet metal flashing such as lead. The cement fillet to the front of the chimney stack has cracked so you should budget to replace all of it with a lead flashing.

Cracked cement fillet to chimney stack

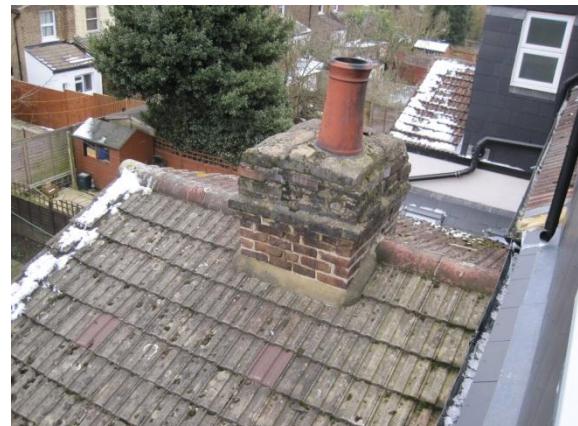
Chimneys stacks to the main part of the property have been removed. There is a brick built chimney stack over the back addition. Brickwork to the stack is messy where it has been patched up in the past and there has been some further erosion to the pointing. The flaunching (the mortar which holds the pot in place) is cracked. A general overhaul is required.

Cracked flaunching to rear chimney stack

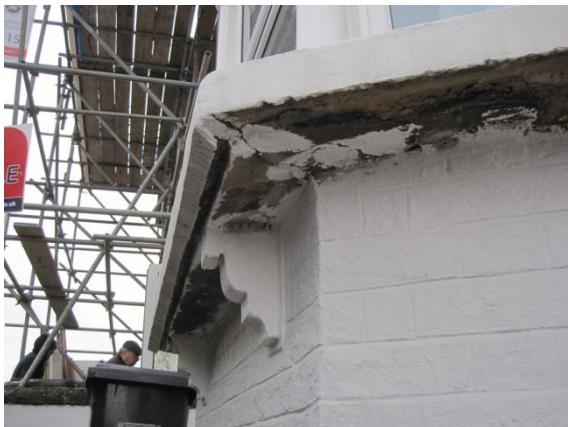
The underside of the stone cills to the front bay window have suffered significant frost damage. This has caused large chunks of the underside, including the drips, to fall away (see also section 5.15 – Dampness). Ideally these should be replaced so that a proper drip can be reinstated which will take rainwater run-off away from the wall below.

Frost damage to underside of front bay cill

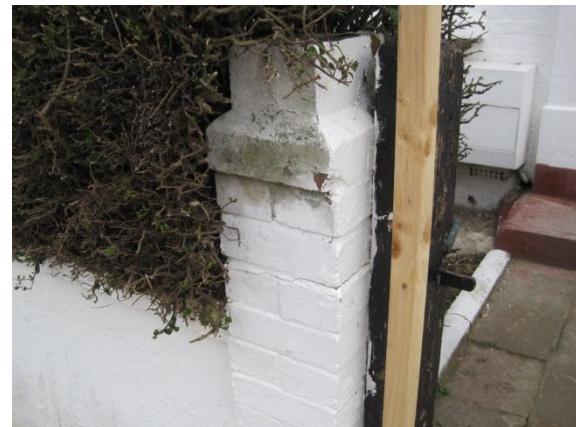
Damaged brickwork to front garden wall

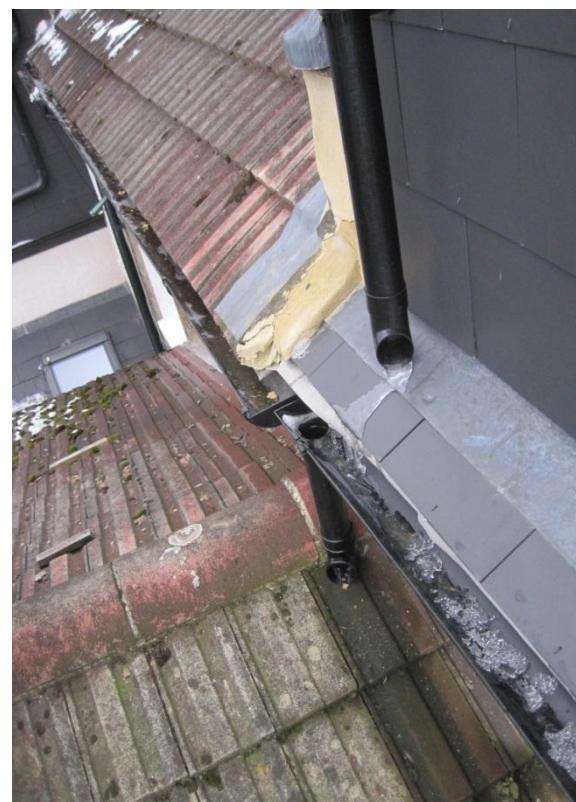
Downpipe discharging on to roof surface
