RICS
HomeBuyer Report...

1 Example Block
Example Road,
Example Town,
Example County,
Example PC

12 April 2013

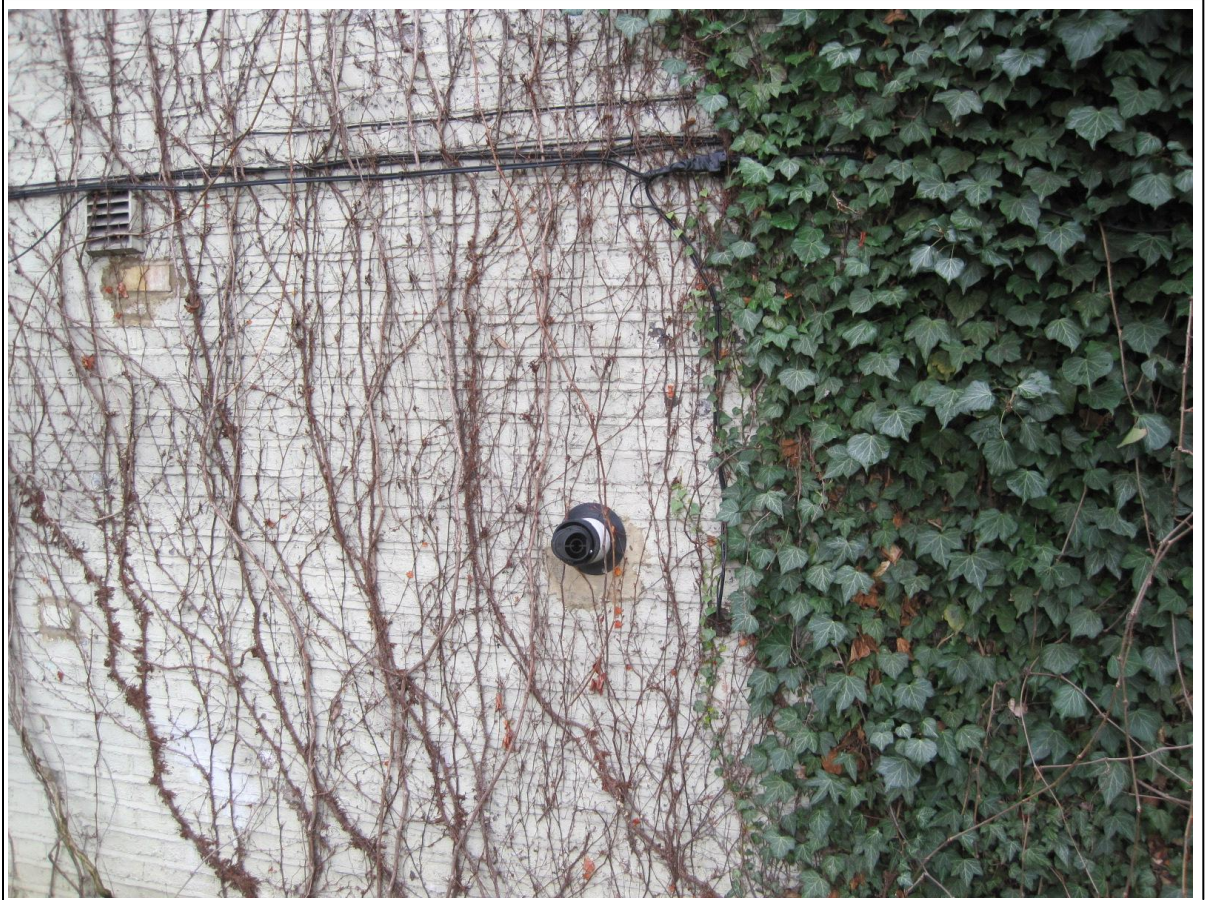
Projecting boiler flue

I recommend that the boiler is tested and serviced by a *Gas Safe* registered engineer.
Condition rating 3.

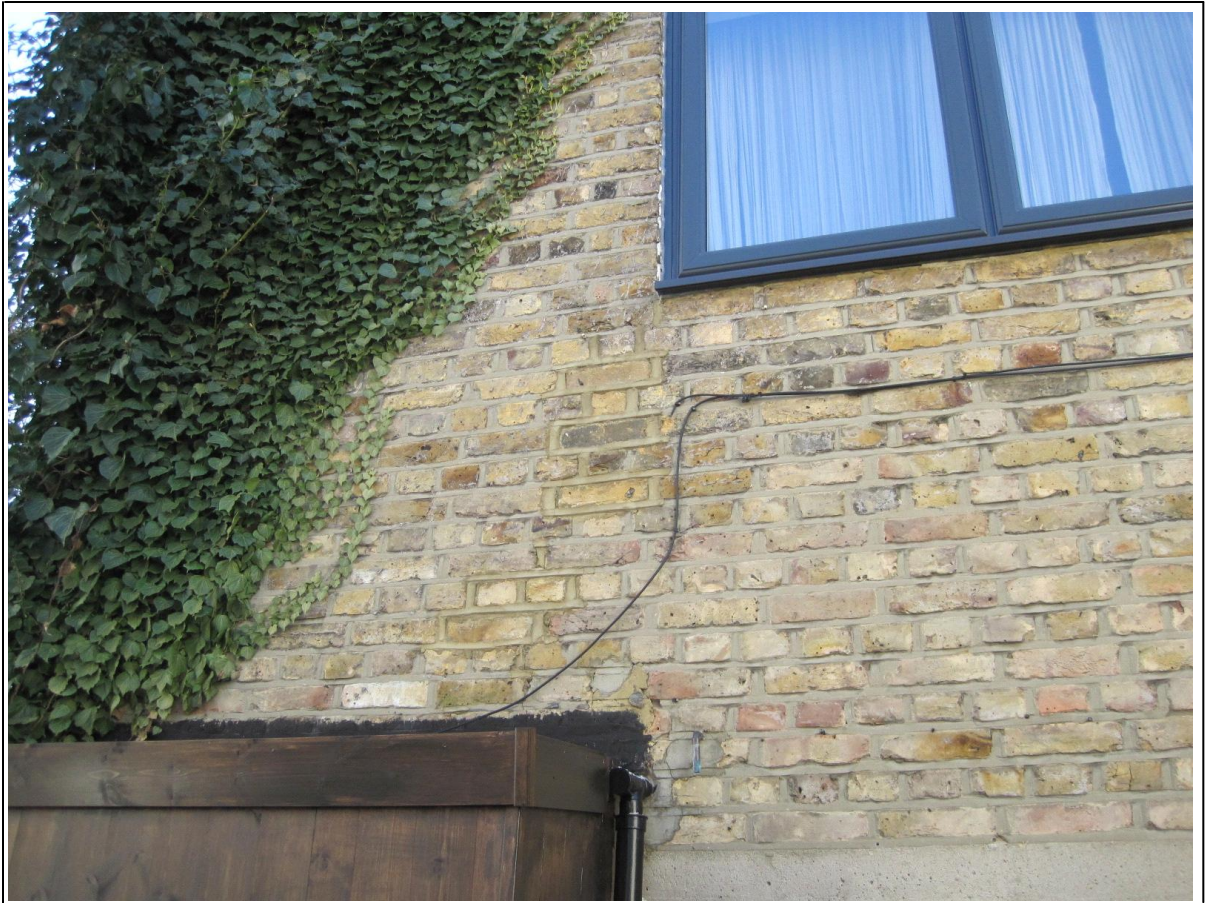
Some re-pointing has been undertaken to the front wall of the property in recent years. In addition there is cracking to the right hand ends of the 2 lintels over the front windows. The pattern of cracking is indicative of some movement to the flank walls and a slight bow is noticeable. There are also a couple straight joints to the right hand flank wall which would suggest previous crack repairs (see also Section J1 - Movement). The extent of the movement is considered to be within acceptable limits. The cracks to the ends of the lintels should be made good to prevent moisture penetration in the future.

Condition rating 3.

Re-pointing to front elevation

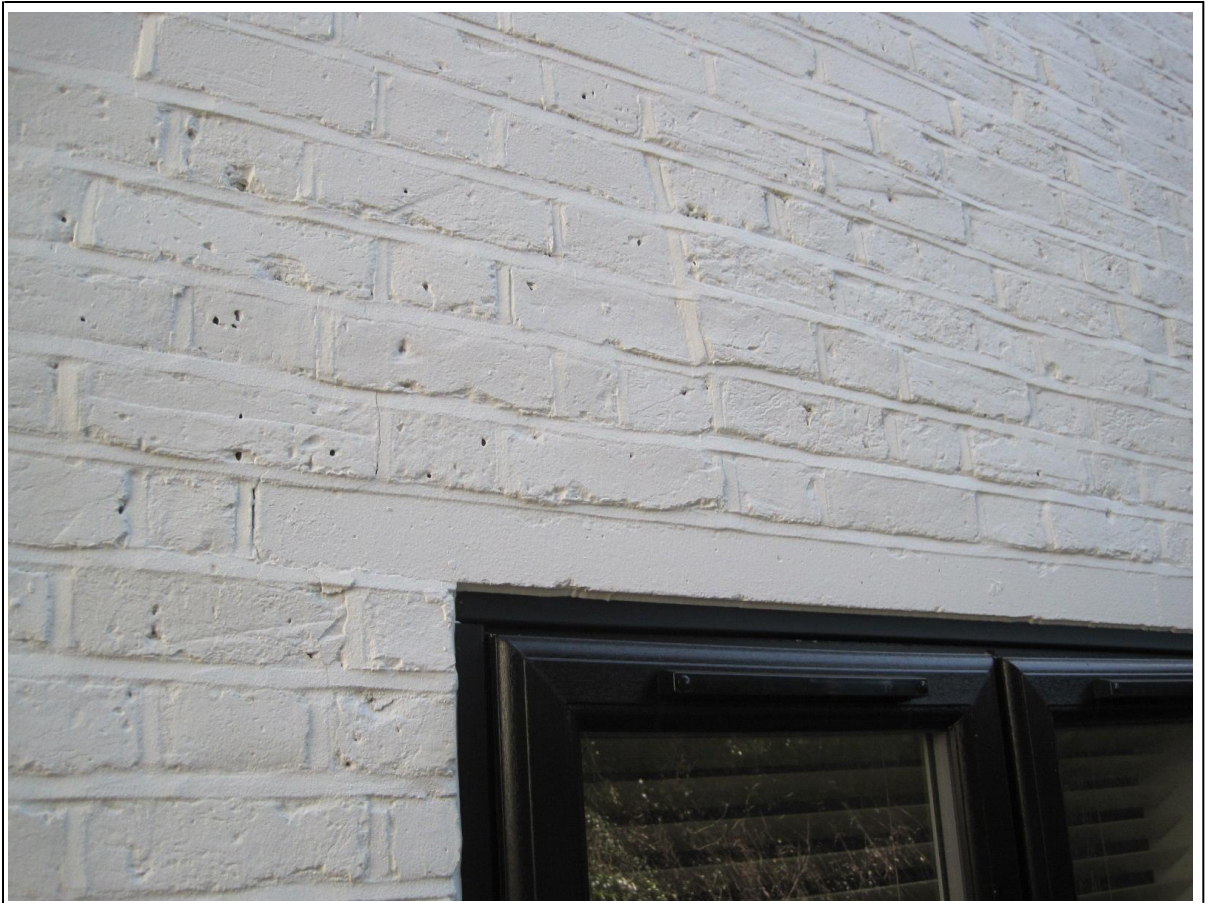
There has been some movement to the structure of the building as evidenced by the cracking to the front and side elevations. I consider this to be within acceptable limits.

Straight joint to flank wall

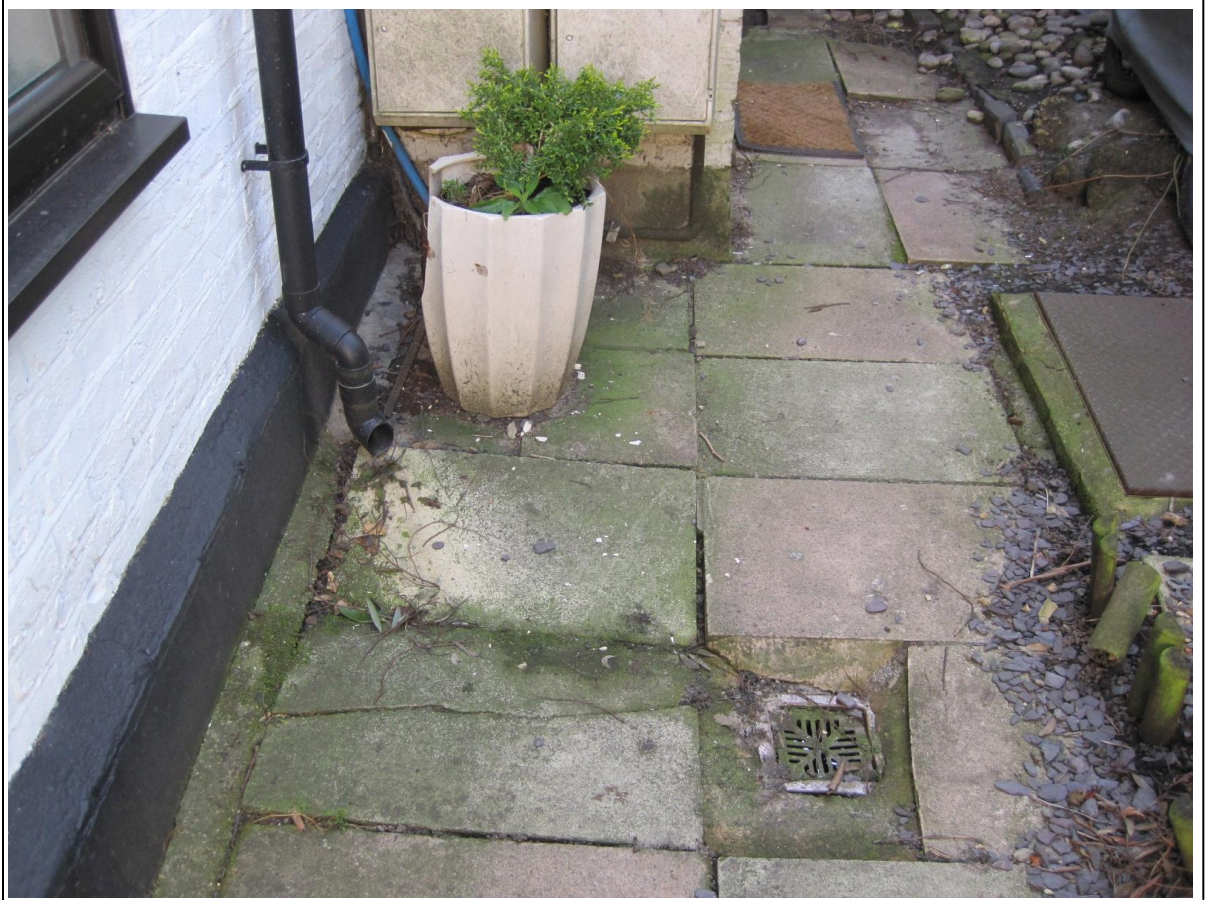
Guttering and downpipes are of plastic type. The downpipe discharges on to the paving at the side of the property from where it drains to a gully that is approximately 1m away. This will be a slipping hazard in freezing weather and should therefore be kept salted in winter. **Condition rating 2.**

The uneven paving to the side of the property is a trip hazard.

The discharge from the rainwater downpipe to the side of the property could be a hazard if it freezes in winter.

Uneven paving and discharge to remote gulley

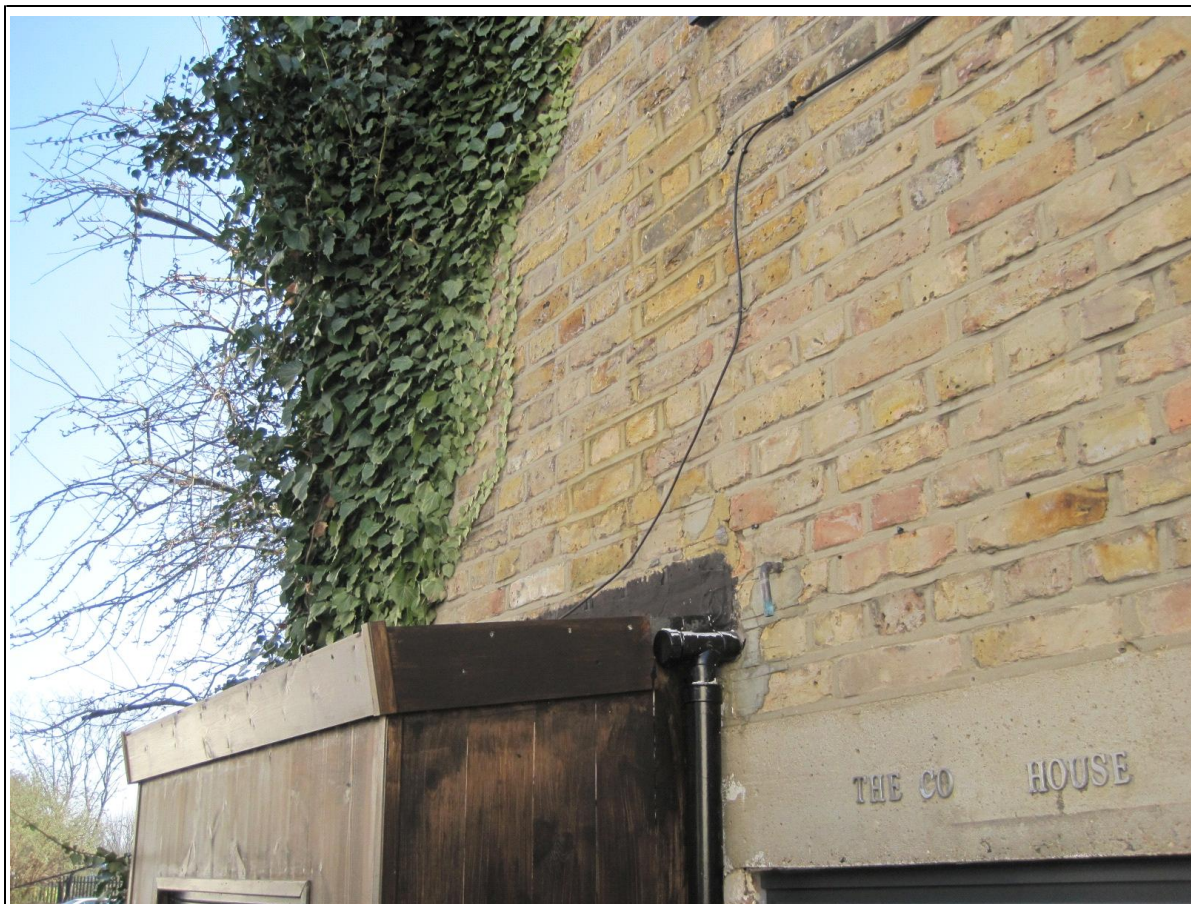
Re-pointing to front wall
